TRIUMPH REGISTER OF AMERICA

Concours d'Elegance

Judging Standards

Restoration Guidelines

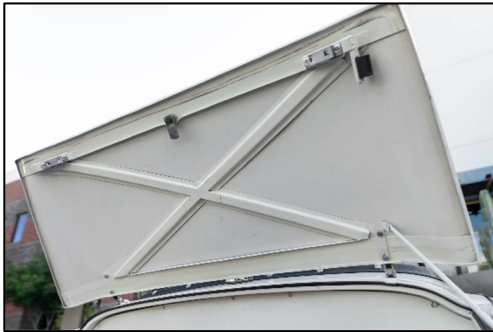
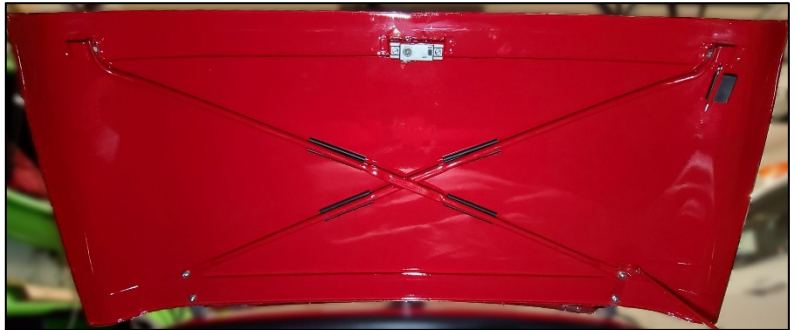
Left photo is of the underside of a TR2-3 boot lid. Right photo is of a post-TS60000 TR3A- TR3B.

From TS60000, tubular ‘X’ support braces with underlying black foam rubber pads replaced the earlier stamped and welded supports. The hinge attachment points now had a slightly raised bezel following the contour of the hinge.

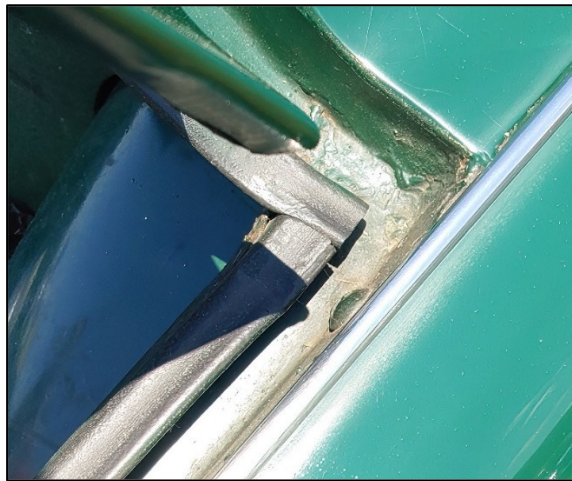
Pre-TS60000 2-piece boot seal joint on RH top of boot opening, the other joint is on LH side.

From TS1, these were two pieces of the same stock glued into a 'double walled' channel surrounding the boot opening. One piece ran along the sides and back channel, with the 'high' portion of the seal facing outward. A second ran along the front channel, with the 'high' portion of the seal facing inward, possibly to reduce fouling on the hinge mounting studs. As these seals were hand cut and applied, the adjoining seams between the two at the upper corners of the drip channel varied, the most common having the 'upper' seal running the full length of the channel with the longer piece butting into its side.

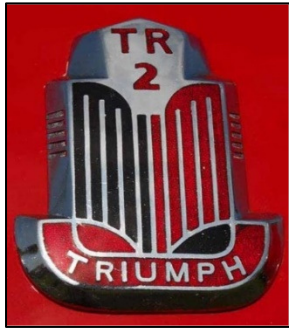
Badge A

Frontal Medallion (Badge) and Name Plates - Bonnet (Letters)

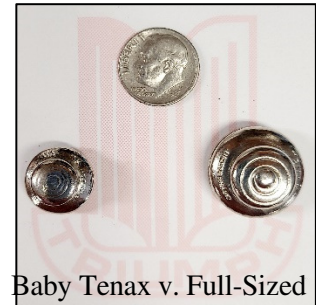
Baby Tenax v. Full-Sized

From TS3513, the lower fasteners changed to full sized 'Tenax'

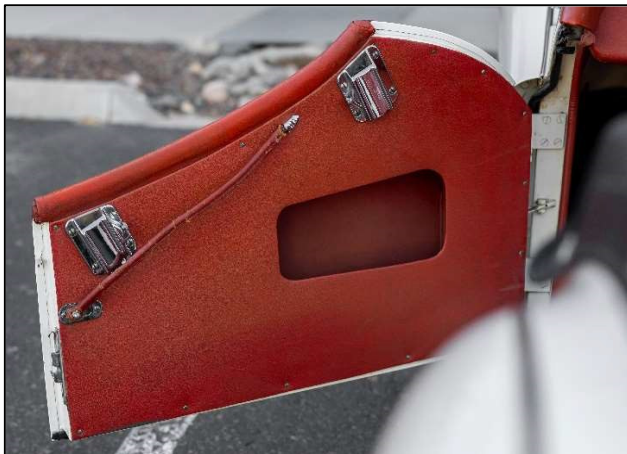
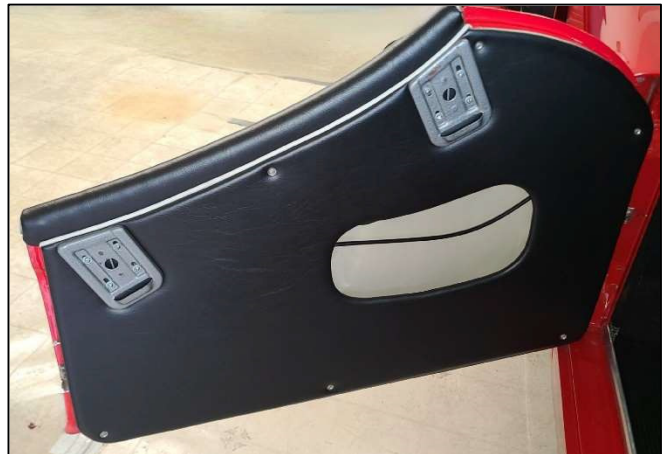
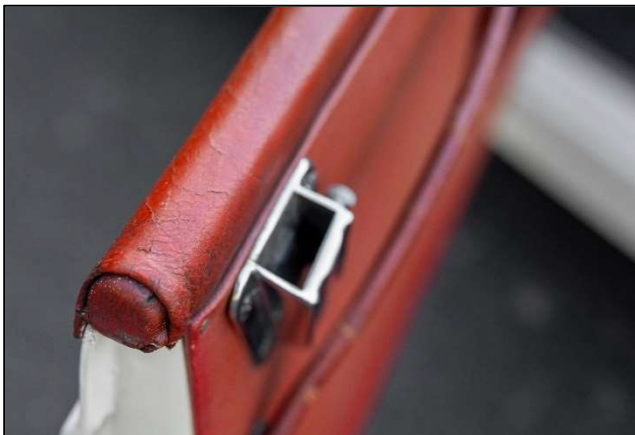
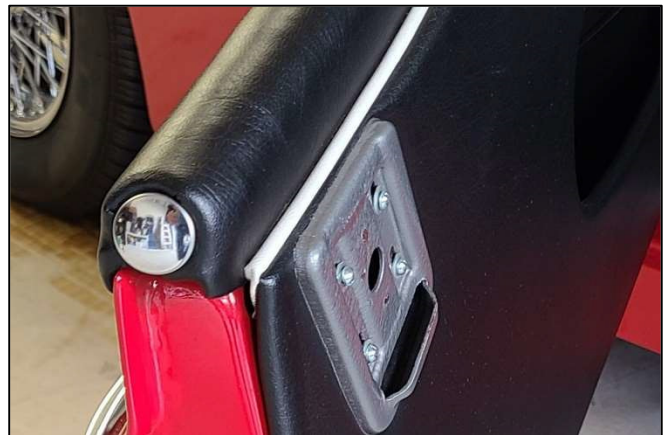
The left photos show door panel details of early TR2s and TR3s. The right photos show details of post TS60000 TR3As through TR3Bs.

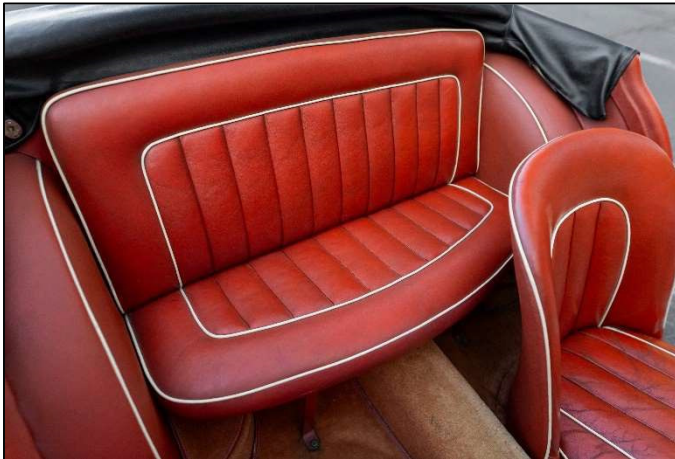
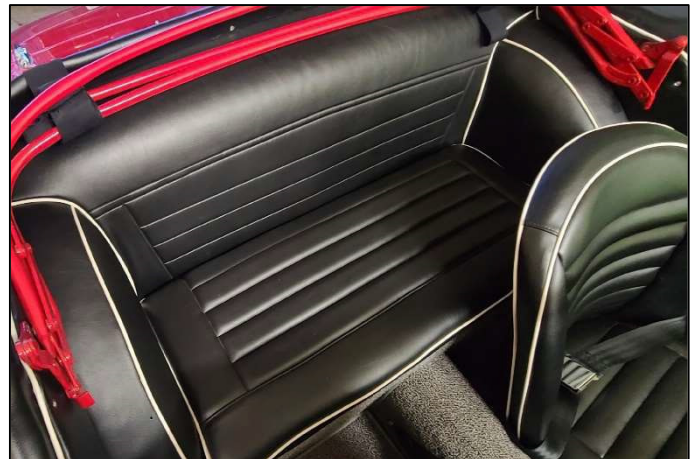
Left photo shows bulkhead panel and occasional seat of early TR2s and TR3s. The right photo shows details of post TS60000 TR3As through TR3Bs.

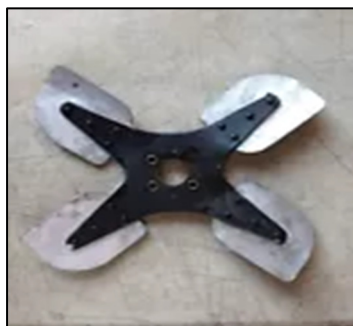
Stock four bladed fan

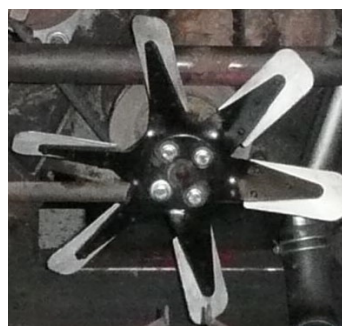
Tropical six bladed fan

Tropical Cooling Fans: Introduced during TR4 production, these six bladed fans are constructed as 'standard' four bladed fans, and attach without modification to a TR2-3B engine, often with significant cooling advantages..

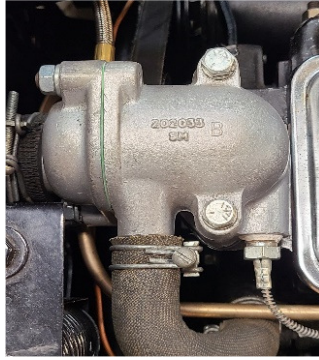
Figure 2

From TS1201E, the thermostat housing changed to a slightly smaller unit with a single chamber lacking a blanking plate secured to the head by two hex headed bolts. This housing was used with minor variations to the end of sidecurtain TR production. (*Figure 2. below*)

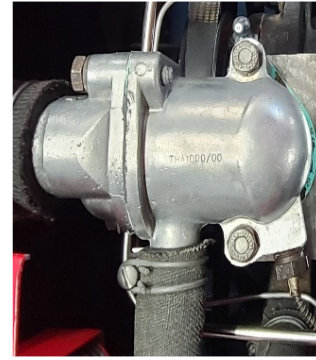
Figure 3

slant of the temperature gauge sending unit flange and stamped rather than raised casting numbers on the upper surface. (*Figure 3. below*)
